**City of Rockport**  
**BUILDING & STANDARDS COMMISSION REGULAR**  
**MEETING AGENDA**  
**WEDNESDAY, JUNE 18, 2025 - 5:30 PM**  
**ROCKPORT SERVICE CENTER**  
**2751 STATE HIGHWAY 35 BYPASS**  
**ROCKPORT, TEXAS 78382**

**STAFF RECOMMENDATION****REPAIR****REPAIR WITH CONDITIONS****DEMOLISH****PROPERTY HISTORY**

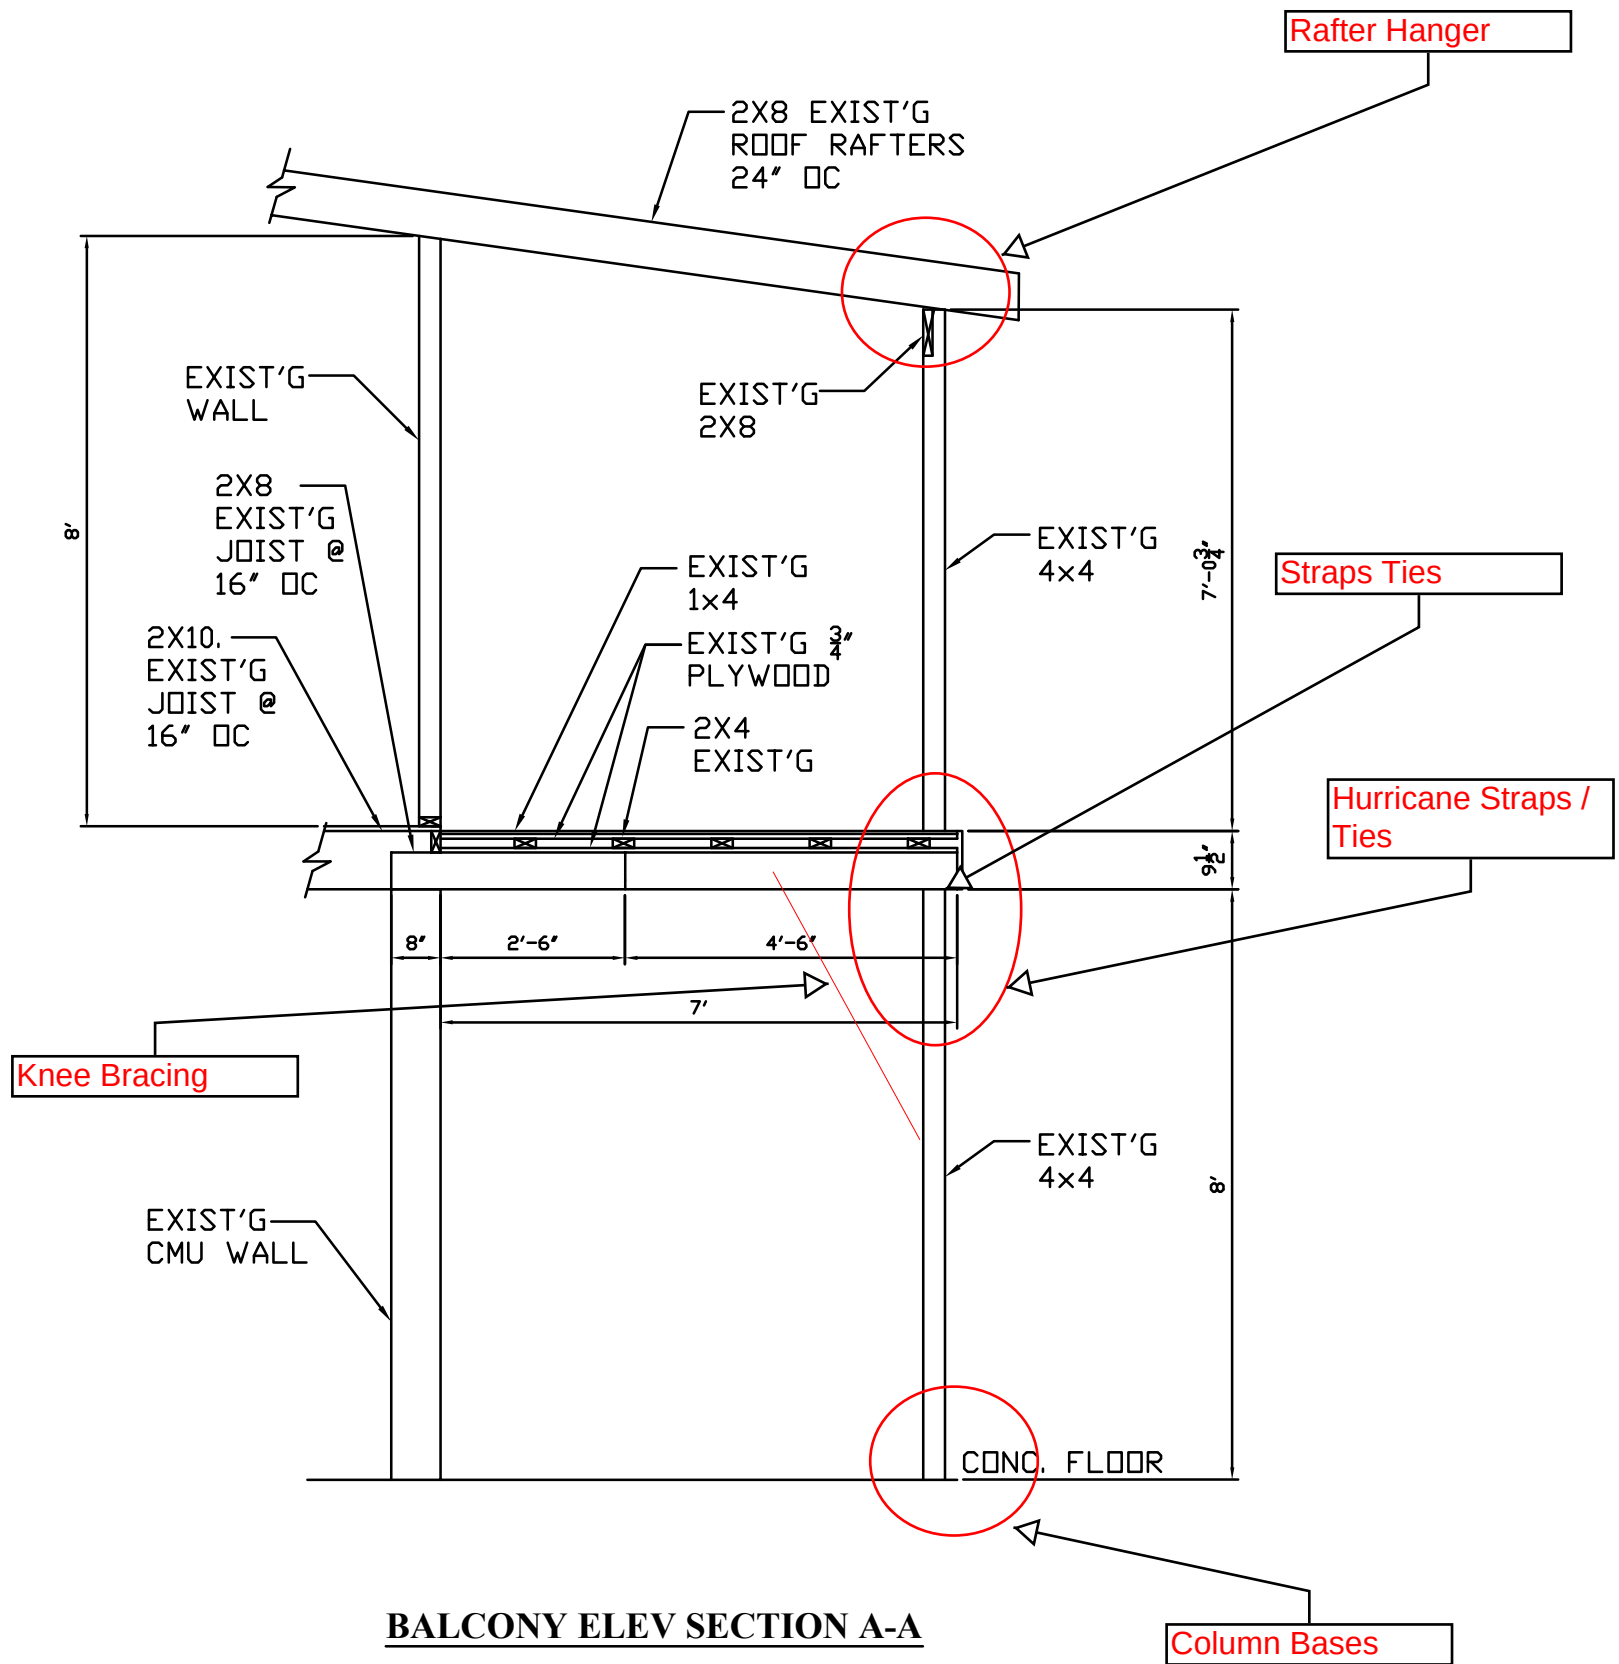
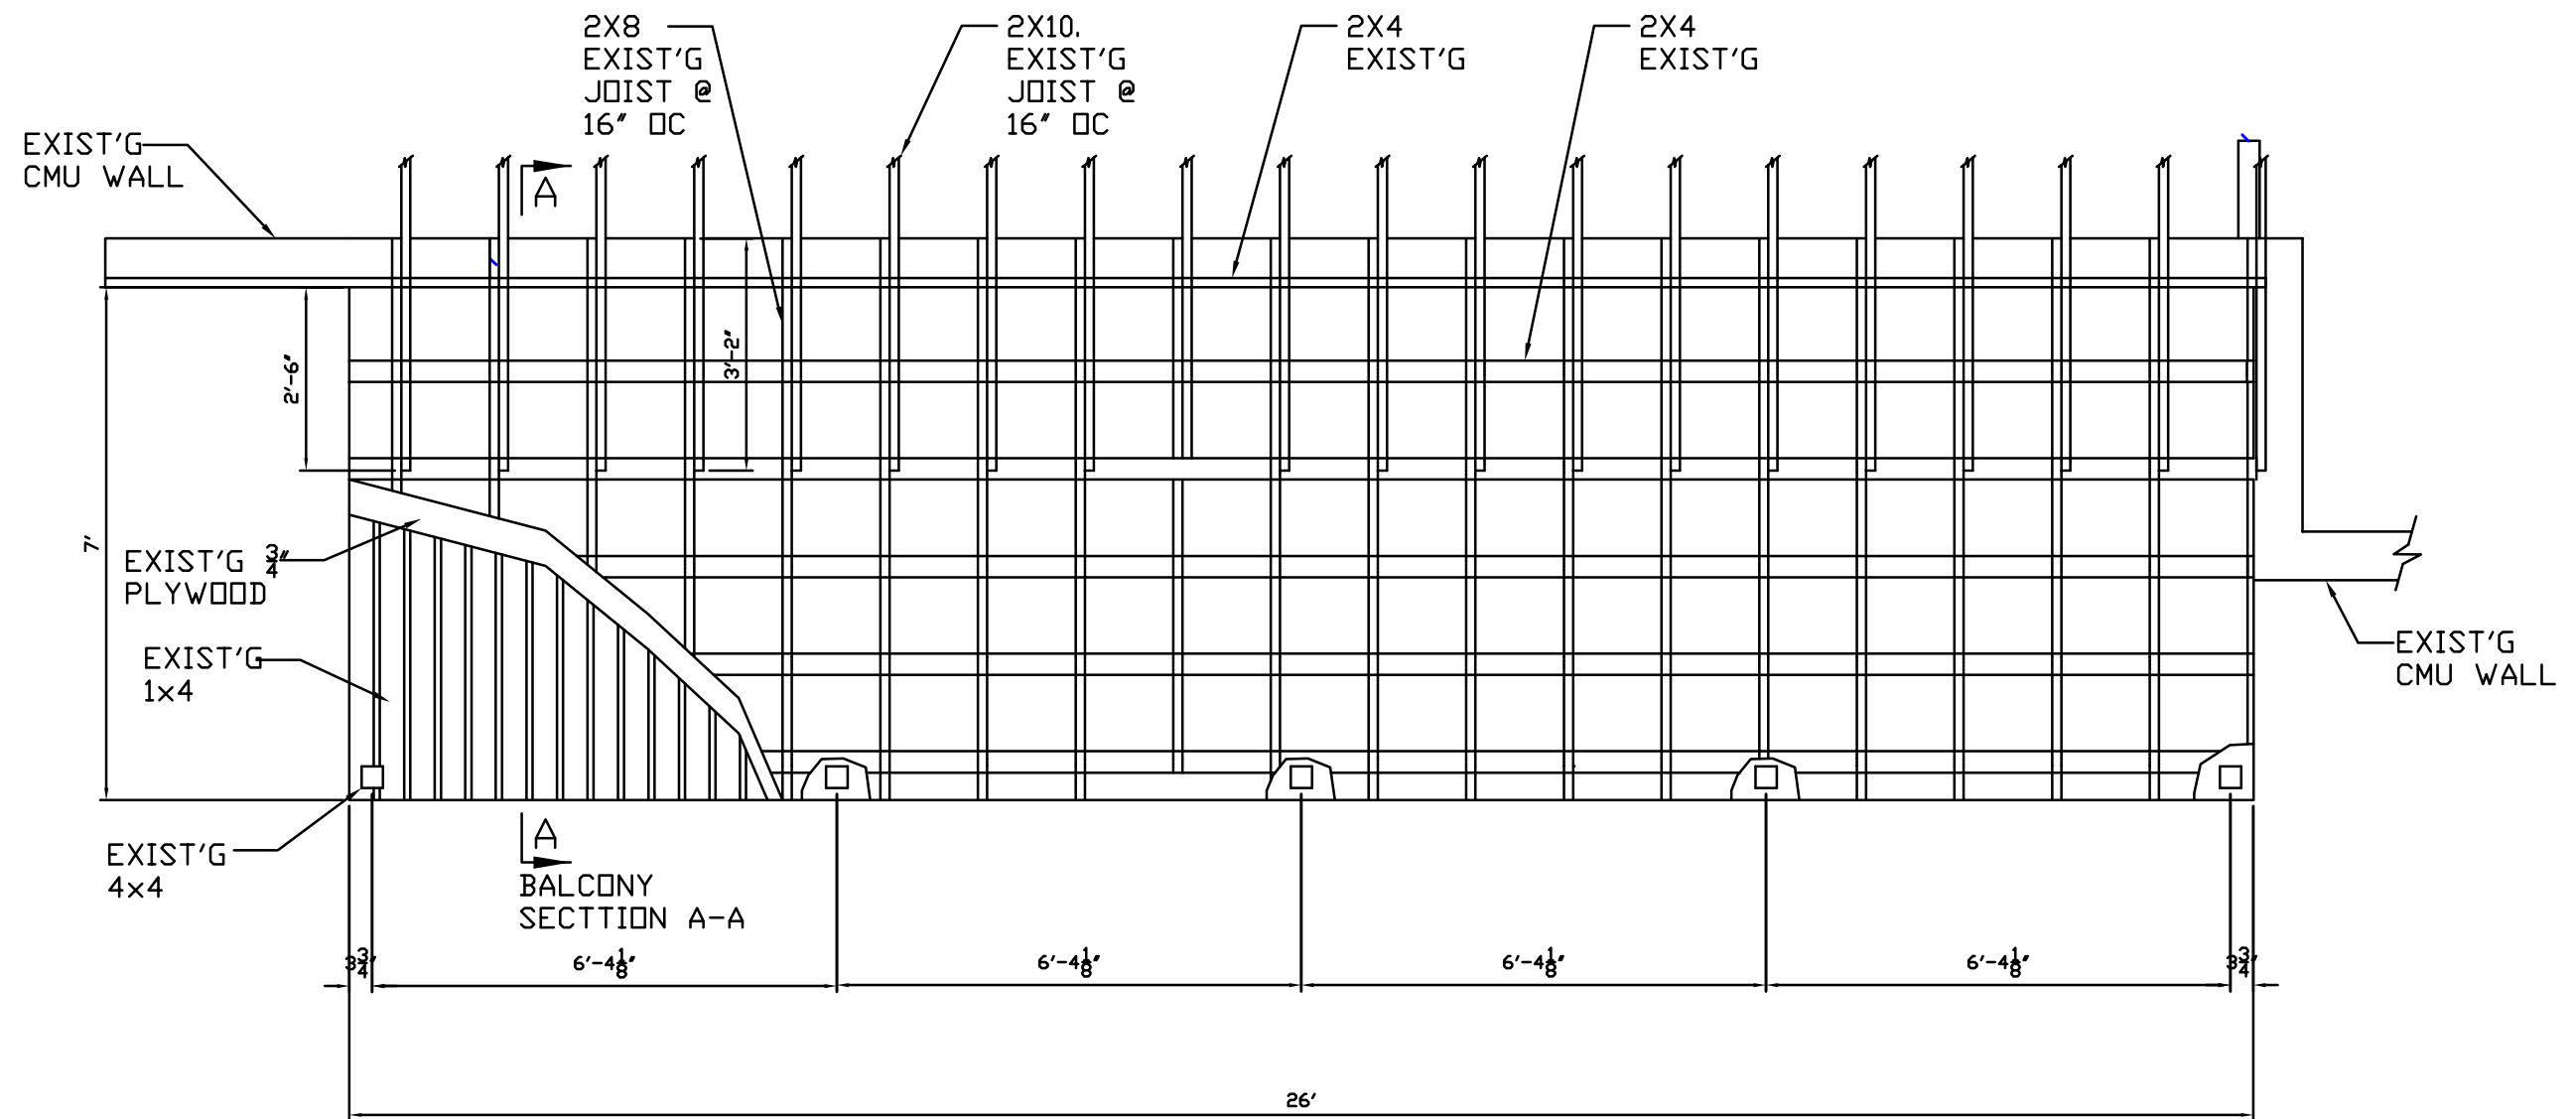
**BALCONY PLAN**

- ✓ CONNECT EXISTING 4X4 WOOD COLUMNS AT THE TOP TO THE HEADER BEAM AND ON THE BOTTOM TO THE CONCRETE FLOOR. SEE TENSION TIES, STRAP TIE, DETAIL PAGES LATER IN THIS REPORT.
- ✓ UTILIZE WIND-RATED CONSTRUCTION METHODS AS PER THE TDI WINDSTORM REQUIREMENTS.
- ✓ ADDING DIAGONAL KNEE-BRACING FROM THE EDGE OF THE BALCONY FLOOR TO THE 4X4 COLUMNS IS RECOMMENDED.
- ✓ HURRICANE TIES ARE RECOMMENDED AT BEAM-TO-COLUMN CONNECTIONS.
- ✓ ATTACH ROOF RAFTERS TO HEADER BEAM AND COLUMNS WITH RAFTER HANGERS – DETAILS ON PAGES LATER IN THIS REPORT.
- ✓ THE FLOOR OF THE BALCONY DECK SHALL BE REINFORCED WITH SOLID BOARD WHEREVER DETERIORATION IS SEEN.
- ✓ GUARDRAIL POST CONNECTIONS TO THE FLOOR SHALL BE REINFORCED WITH APPROPRIATE CONNECTORS.

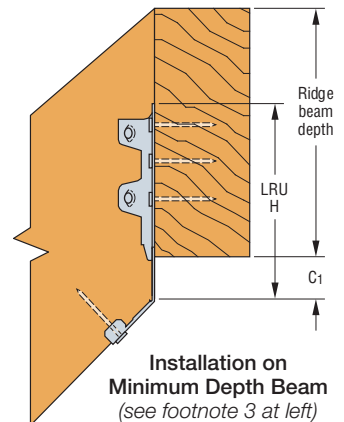
Installation on Minimum Depth Beam  
(see footnote 3 at left)

1. Minimum ridge beam depths shown assume that the rafter and the ridge beam are flush at the top.
2. Minimum ridge beam depths have been determined to ensure the maximum C<sub>1</sub> dimension for the LRU is not exceeded. Deeper ridge beams may be required to support the rafter loads as determined by the designer.
3. Per the 2012/2015/2018/2021 IRC Section R802.3 the ridge is required to be not less in depth than the cut end of the rafter unless the ridge is designed as a beam.
4. Slopes greater than 12:12 are download only.

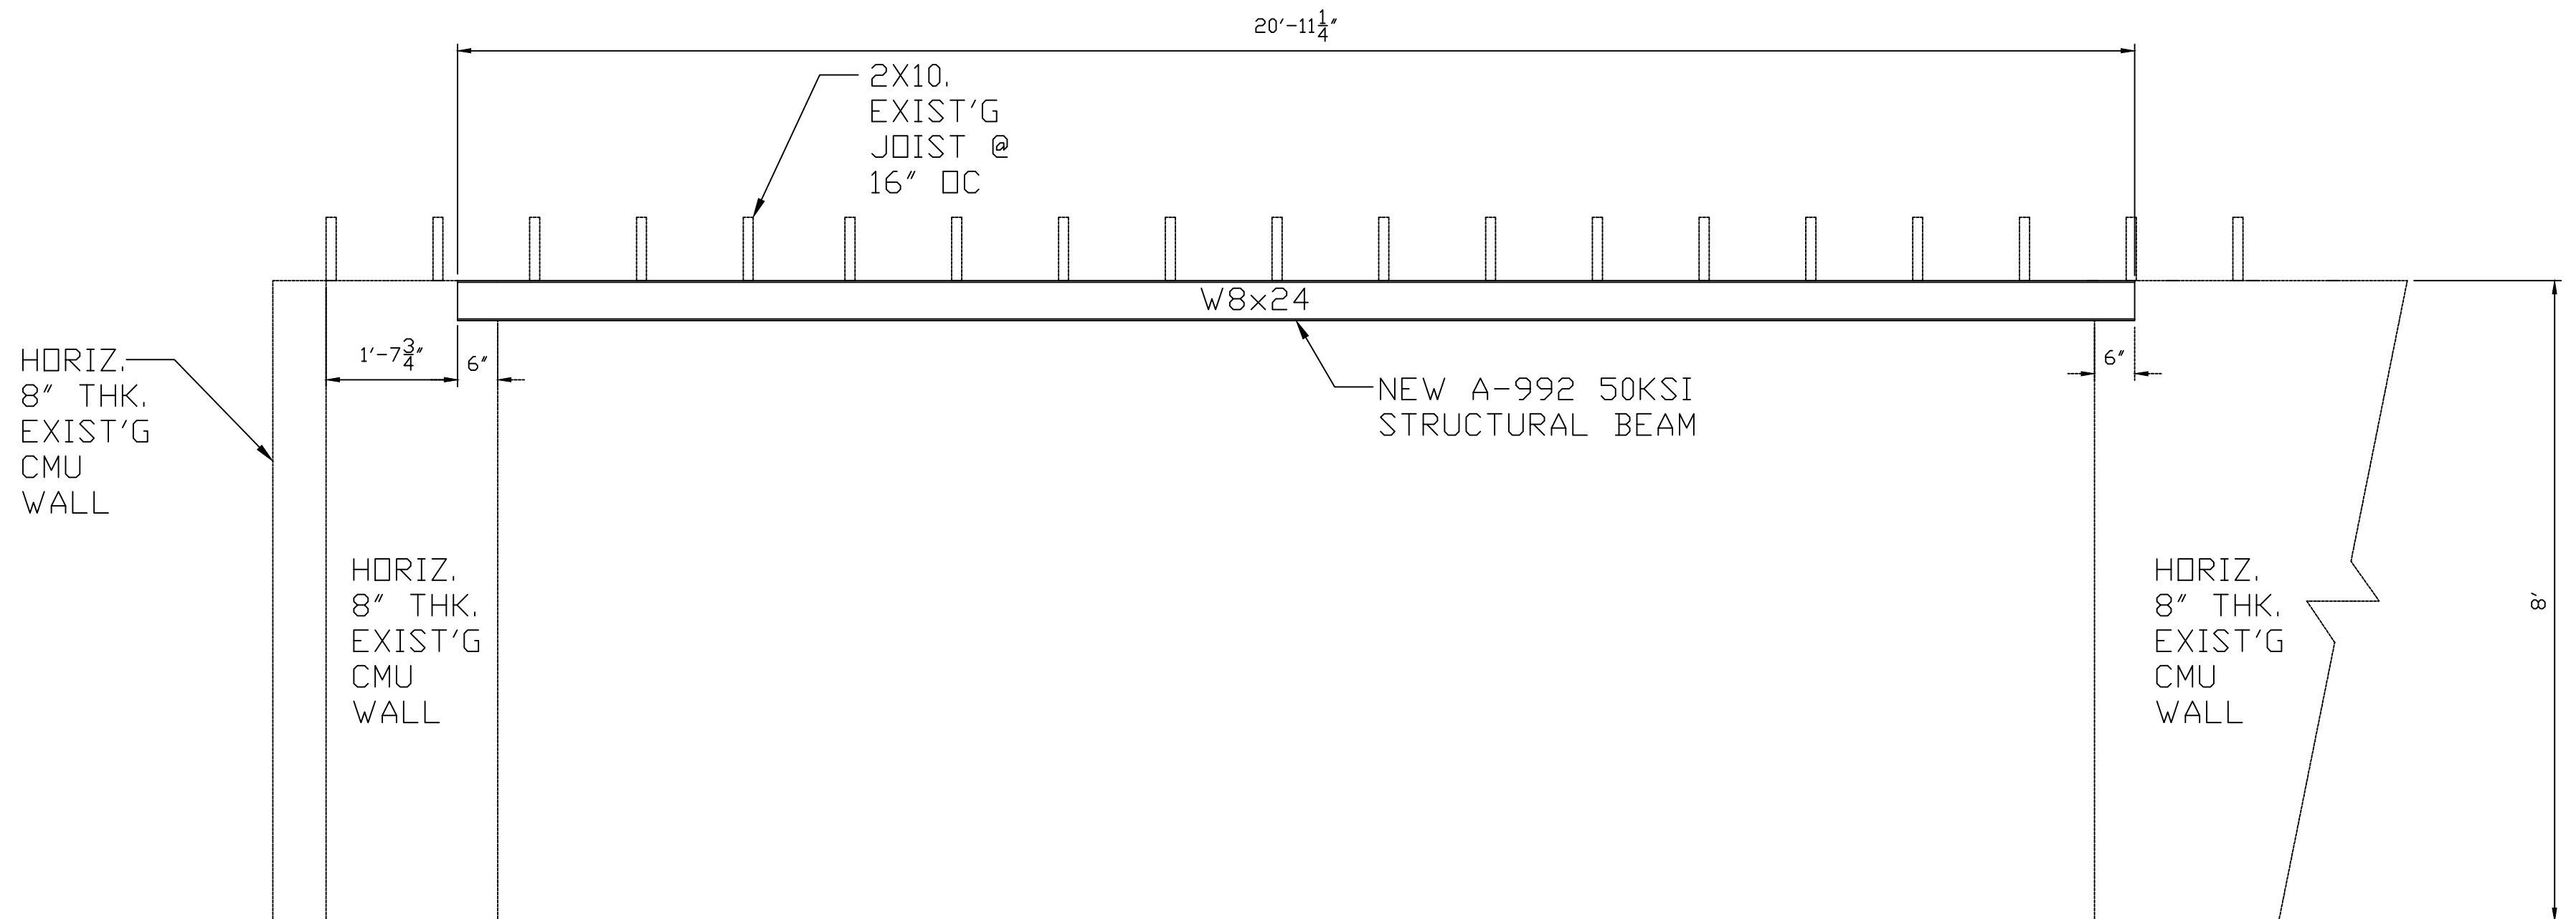
**STRUCTURAL BEAM DOWNSTAIRS**

**A-992 50 KSI HOT ROLLED STEEL BEAM**

- a) **AISC Rolled Steel Section W8x24**
- b) **lateral bracing at 24" o.c. or less  
along its entire length**
- c) **Minimum Bearing Length 6-inches  
at Each End / Support**

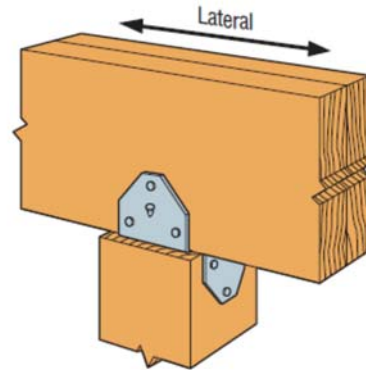
Typical BCS Installation

- 
- **B C S 2 - 3 / 6 SIMPSON post cap with (12) 0.162" dia. X 3 1/2" long - SDS Connectors to Beam Flange, and (6) 0.162" dia. X 3 1/2" long - SDS Connectors to Post, OR APPROVED EQUAL.**

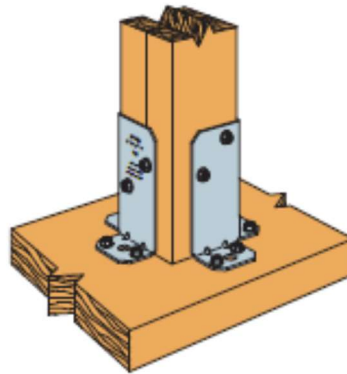
RPBZ Installation  
on Wood

- 
- **RPBZ SIMPSON retrofit post base with (8) 1/4" x 3" SDS Connectors to Floor Beam, and (8) 1/4" x 1 1/2" SDS Connectors to Post, OR APPROVED EQUAL.**

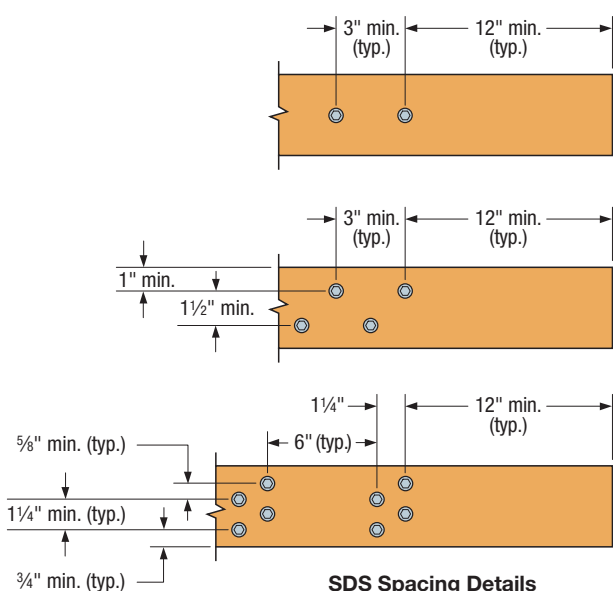
SDS Spacing Details

4. Minimum spacing of fasteners is 3" o.c., minimum end distance is 3" for all parallel-to-grain loaded members, or 4" for all perpendicular-to-grain loaded members, and minimum edge distance is ¾" for all parallel-to-grain loaded members, or 1½" for perpendicular-to-grain loaded side members.

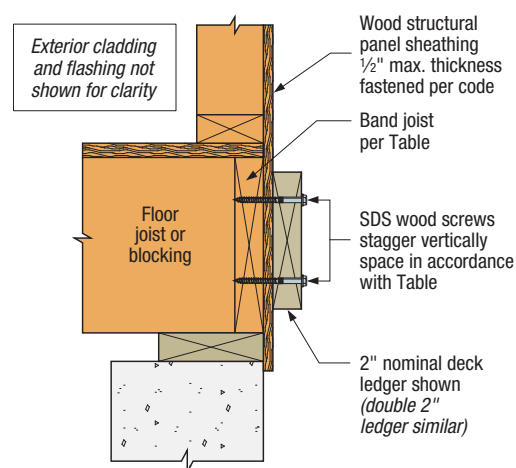
**Ledger-to-Rim Board Assembly**

(Wood-framed lower floor acceptable, concrete wall shown for illustration purposes)

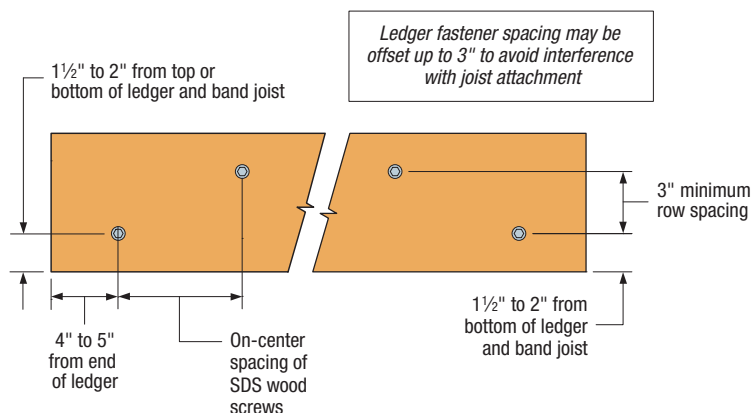
**SDS Screw Spacing Detail for Ledgers**

4. SDS screw spacing values (above) are equivalent to 2009 IRC Table R502.2.2.1 and 2012/2015 IRC Table R507.2, based on testing of the Strong-Drive® SDS screw with a factor of safety of 5.0. The table above also provides SDS screw spacing for a wider range of materials commonly used for rim board, and an alternate loading condition as required by some jurisdictions.
5. Screw models SDS25312, SDS25312SS and SDS25500.

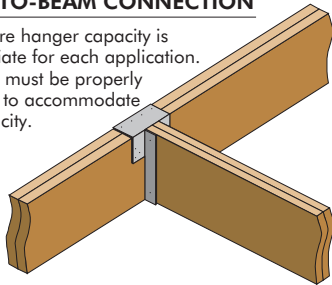
### BEAM-TO-BEAM CONNECTION

Make sure hanger capacity is appropriate for each application. Hangers must be properly installed to accommodate full capacity.

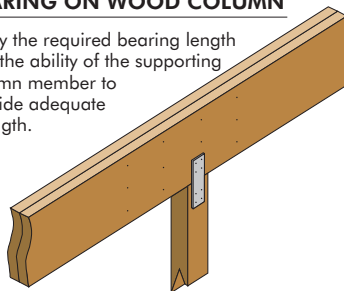
### BEARING ON WOOD COLUMN

Verify the required bearing length and the ability of the supporting column member to provide adequate strength.

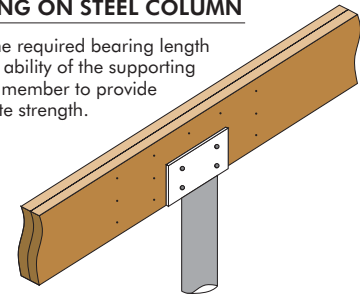
### BEARING ON STEEL COLUMN

Verify the required bearing length and the ability of the supporting column member to provide adequate strength.

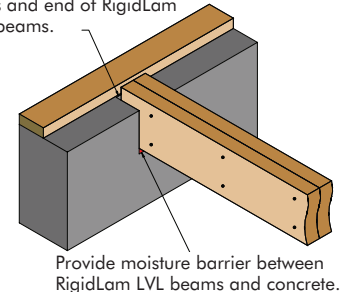
### POCKET CONSTRUCTION

Provide 1/2" air space on top, sides and end of RigidLam LVL beams.

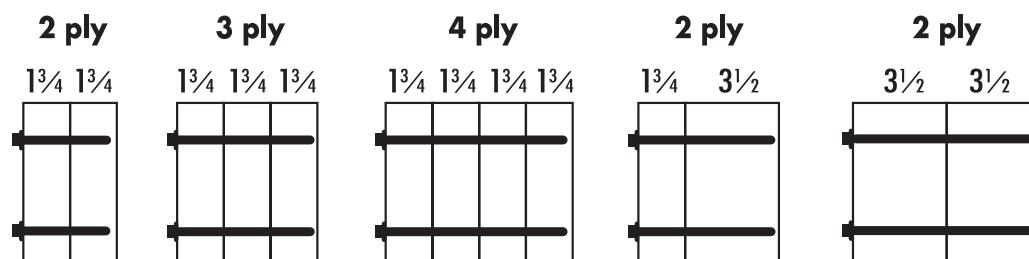
The diagrams above are for illustrative purposes only, screws may need to be applied to both sides. Refer to the manufacturers' information for the appropriate design and installation guidelines.

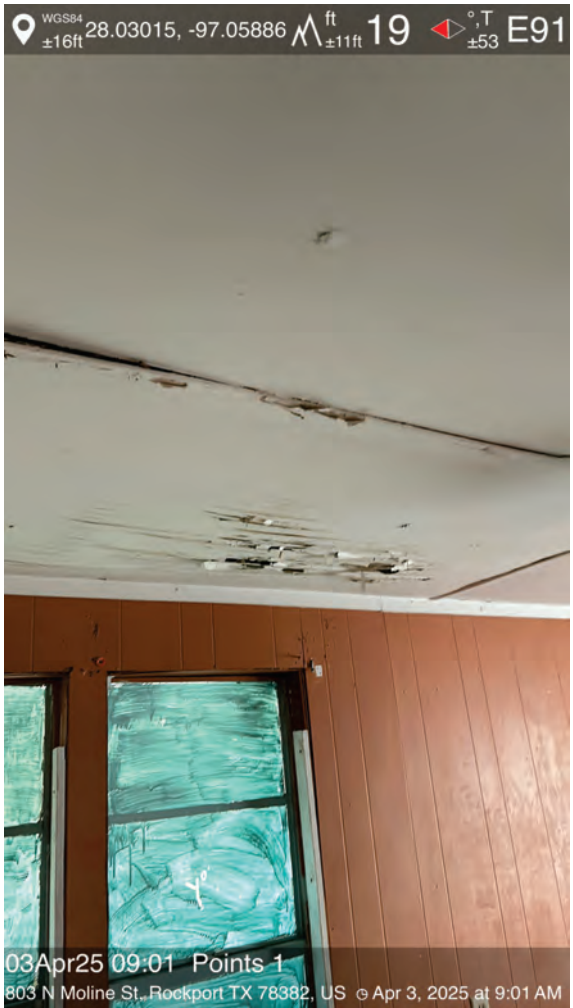
WGS84  
±16ft  
28.03015, -97.05886  
ft 19  
±11ft  
°T E91  
±53

On April 2, 2025, a search warrant was issued by Judge Bianchi and executed on April 3, 2025. As a result, the following deficiencies were found at the premises; The front porch has rotten boards and the railings are falling and rotten, there are cracks and holes in the stucco and inside and outside of the structure. Several of the windows have been replaced but are not the correct size and a lot are partially covered, and the roof has a sway in it. There is Romex wiring on the outside of the structure. There is water damage throughout the structure, and holes in the flooring.

Code Enforcement Officer Judy Emerson is requesting that the structure that sits on the east side of this property and is addressed as **801 Moline St.** be demolished, and all debris, junk and trash be removed and the property be returned to its natural state.
